## 1.0 EXECUTIVE SUMMARY

All past planting and future planned plantings are as per the MEZ Planting Plan 327-335 Burley Road Horsley Park 29<sup>th</sup> August 2019 completed by Ecological Australia Pty Ltd

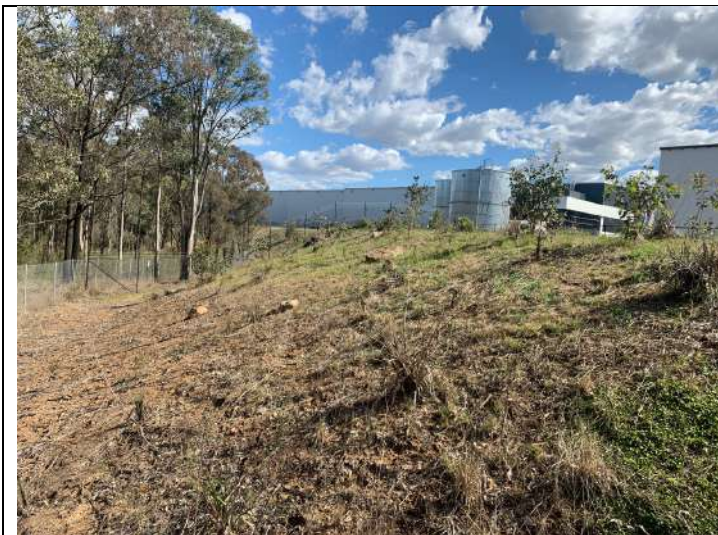
Photo 1 MEZ Condition

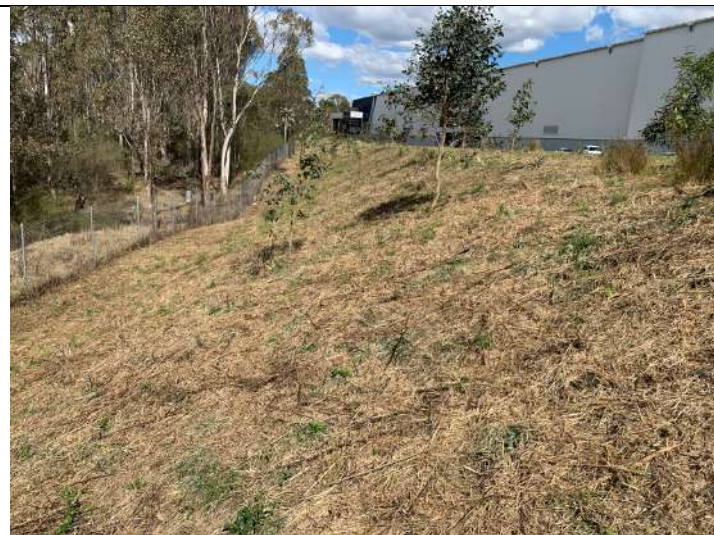
| Requirement | Status | Notes |
|---|---|---|
| Weed Control | Ongoing | Continued weed control was undertake within the MEZ through out 2023 the majority of this work consisted of manual weed removal around native species and herbicide application of invasive species such as <i>Echinochola Sp</i> (barn yard grass), <i>Setaria sphaeclata</i> (Pidgeon grass), <i>Paspalum dilatatum</i> (Paspalum) <i>Cirsium vulgar</i> (Thistle), <i>Bidens Pilosa</i> (Cobblers Peg), <i>Conzya sp</i> (Fleabane), <i>Sisymbrium officinale</i> (Mustar Weed) <i>Datura stramonium</i> (Datura) and <i>Chloris gayana</i> (Rhodes grass).<br><br>Herbicide application to the MEZ is our current ongoing priority. |

Photo 2 Herbicide spraying

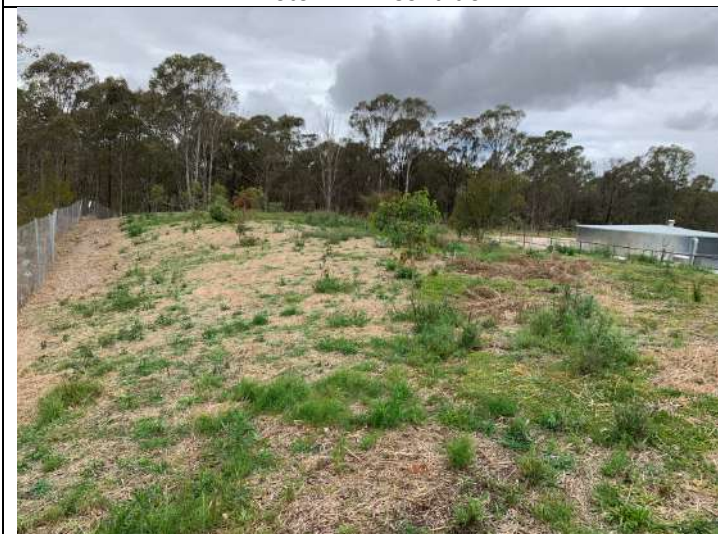
Photo 3 MEZ Condition

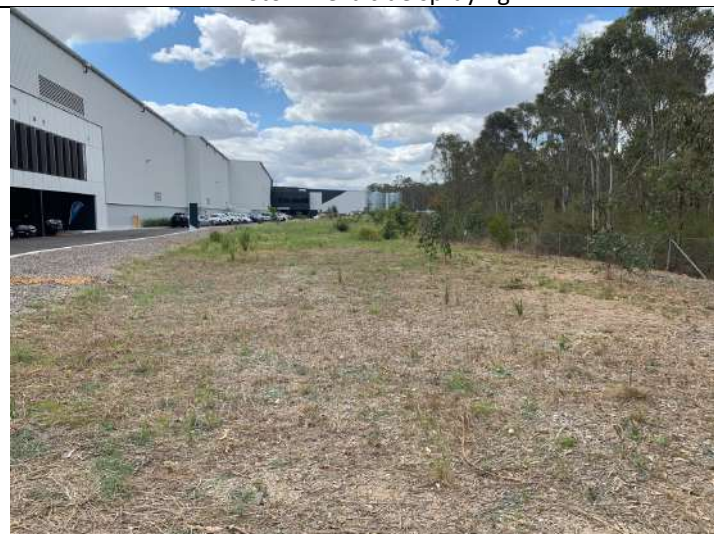
Photo 4 MEZ Condition

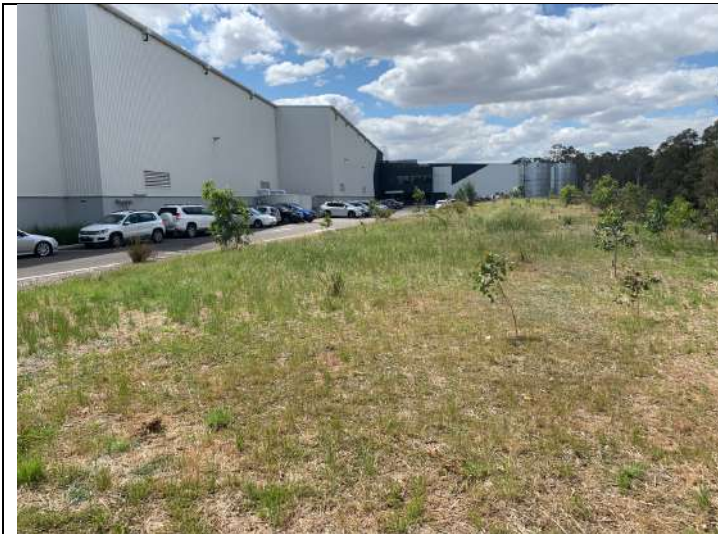
MEZ Native Cover

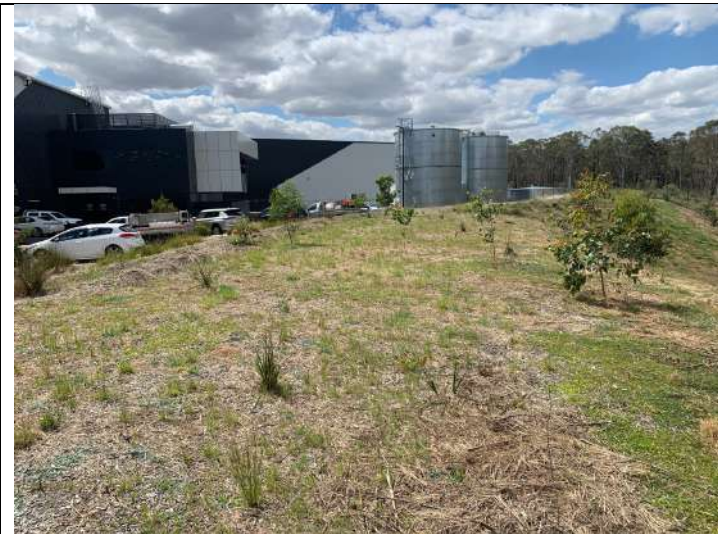
MEZ Native Cover

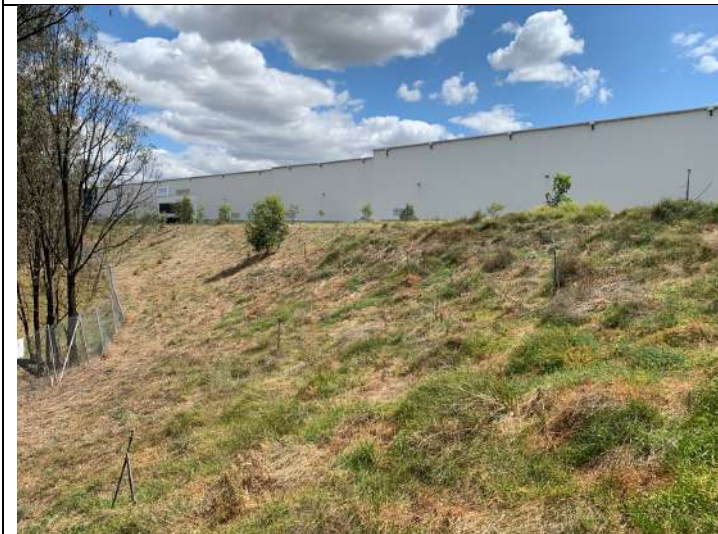
MEZ Native Cover

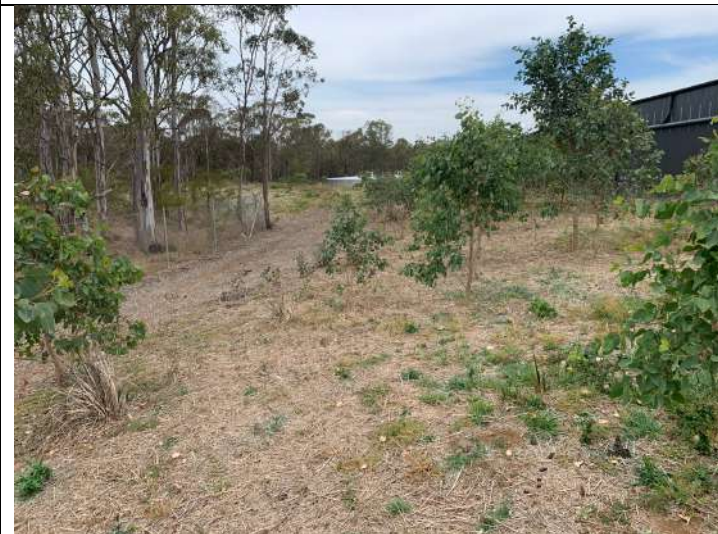
MEZ Native Cover

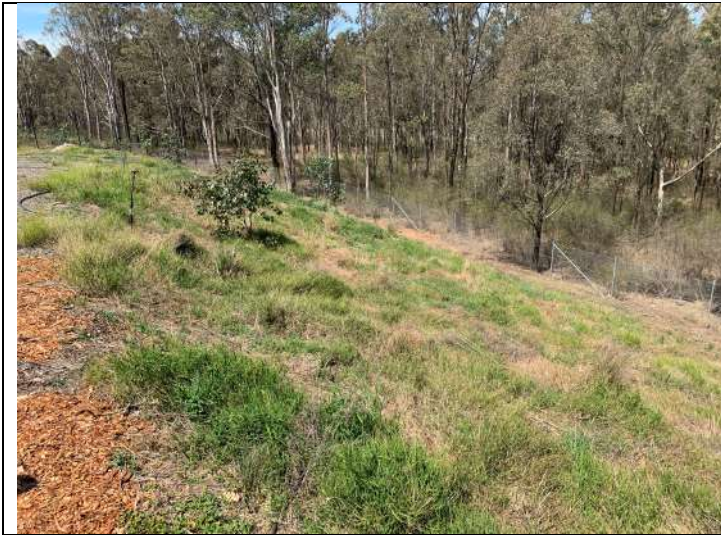
| Requirement | Status | Notes |
|---|---|---|
| Monitor and report any erosion/slippage issues | Completed | No erosion or slippage issues observed in 2023 planting installed within previously repaired slippage are establishing well. |

Previous Slip Area

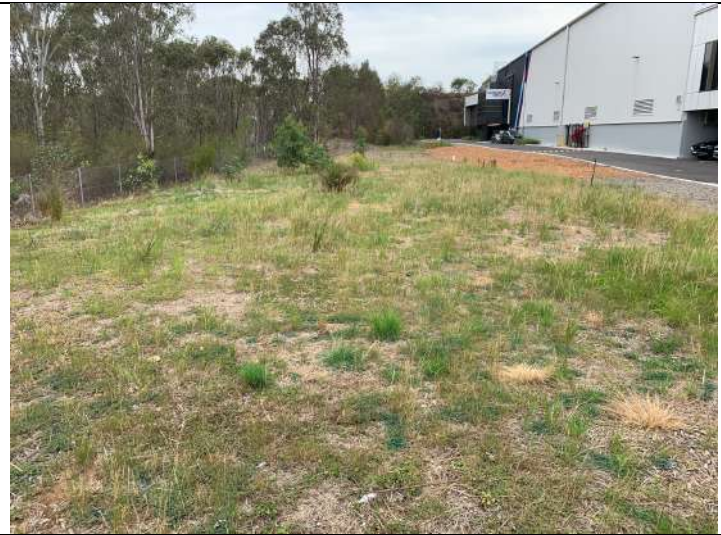
MEZ Native Cover
